EXPLORATORY STUDY OF CONDITION AND FACTORS OF DECAY OF ARCHITECTURAL SURFACES CARRIED OUT BY CONSERVATORS/RESTORERS

IVO HAMMER

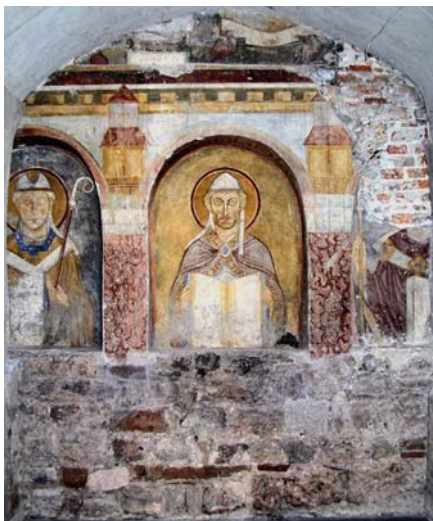
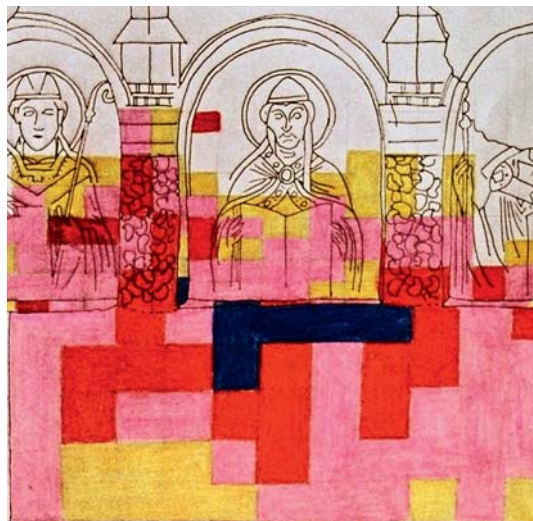
Fig. 1-2. Salzburg, Austria, Nonnberg Benedictine nunnery, former paradise, wall painting, mid 12th Century, church fathers, left: after cleaning. Photo Hammer, 1995; right: ELC 1987 Bundesdenkmalamt / Hammer.

tool by the PROTIMETER company designed for the measurement of the moisture content of wood. In 1977 I developed a visualisation method using a grid system with different shades. (fig. 1-2)

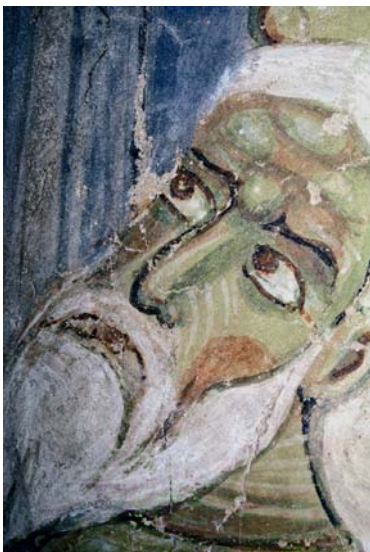
Fig. 6-7. Lambach, Upper Austria, former west choir, wall painting 1080 approximately; left: North-west wall, healing of hemophiliac, detail, and the cracks are caused by overloading of the Roman wall in increasing the towers in 1639. Photo Hammer, 1983; right: documentation of the ELC to define the areas that need to be particularly monitored. Bundesdenkmalamt / Hammer.

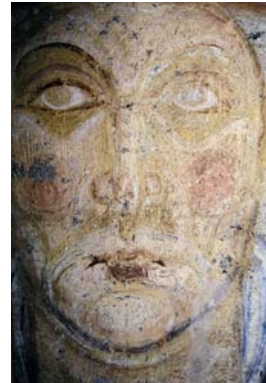
Fig. 8-9. Salzburg, Austria, Nonnberg Benedictine nunnery, former paradise, wall painting, mid 12th Century, church fathers; left: documentation of the history of preservation; right: Niche 5, detail: the right half of the face was probably never covered, and the left half was covered in 1423 by the substructures of the nun gallery; in 1955 the overlapping walls were removed.

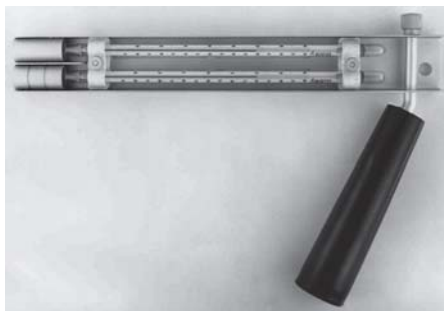
Fig. 10-11. Left: Sling psychrometer to measure easily temperature and RH, also to calibrate other devices; right: Inglesham, Wiltshire, UK, St. John the Baptist, Graphical representation of monthly values of humidity and air temperature: maximum values, averages, minimum temperatures. HAWK / Rossel / Rutherford / Hammer 2007.

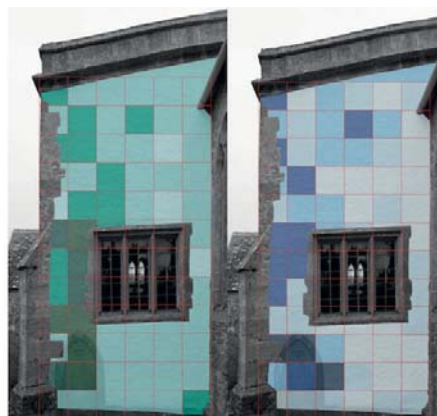
Abb. 6.10.: ELF und KAP Messungen Oktober 2006
rLF [%] : 70,4 / T° [°C] : 15,3°C

Abb. 6.11.: ELF und KAP Messungen April/Mai 2007
rLF [%] : 52,2 / T° [°C] : 17,2°C

Fig. 16-18. Left: Devices to measure the CAP, with ball head; right: Inglesham, Wiltshire, UK, St. John the Baptist, southeast wall; the graphical representation of measurement of the ELC (green) and the CAP (blue). The comparison of the measurement of October 2006 (15 ° C, 70% RH) and by April 2007 (17 ° C, 52% RH) indicated hygroscopic moisture as the cause of the measured values: The ELC measurement of October shows significantly higher values than the CAP-measurement. HAWK / Teeken / Wander / Rutherford / Hammer.

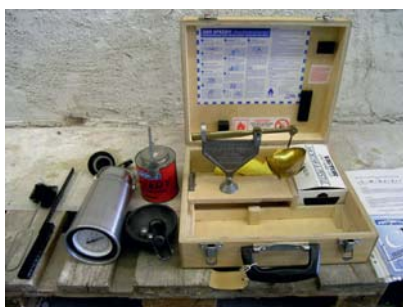
Fig.19-21. a) CAP measurement equipment; b) form to document CAP; c) 2 types of different results: of CAP and the related diagrams.

The measurements revealed basically two different types of measurement results. Near the ground, *i.e.* about 30 cm high where we can expect natural infiltration of moisture, the measured values were higher with increasing depth. The second hole, approximately 1 m in height, supplied mostly readings that are lower in depth than in the surface area. We documented the results in a format in which all relevant parameters are recorded: location and depth of the hole (from-to cm), amount and type of drilling dust, *i.e.* type of masonry, pressure, and mass percentage of moisture (as shown in the table). Also noted on the form are the executing company and person, date, time, temperature, RH, material condition of the surface, ELC and CAP. The measurement results are finally documented in a diagram.

Regarding the interpretation of the measured values, I can state the following. Measured values, which increase in the depth of the wall, suggest that the origin of the humidity is the capillary moisture infiltration, such as soil moisture, damaged drainage pipes, leaking roof, etc. However, measured values that will decrease with the depth of the wall indicate that the origin of the moisture is on the surface of

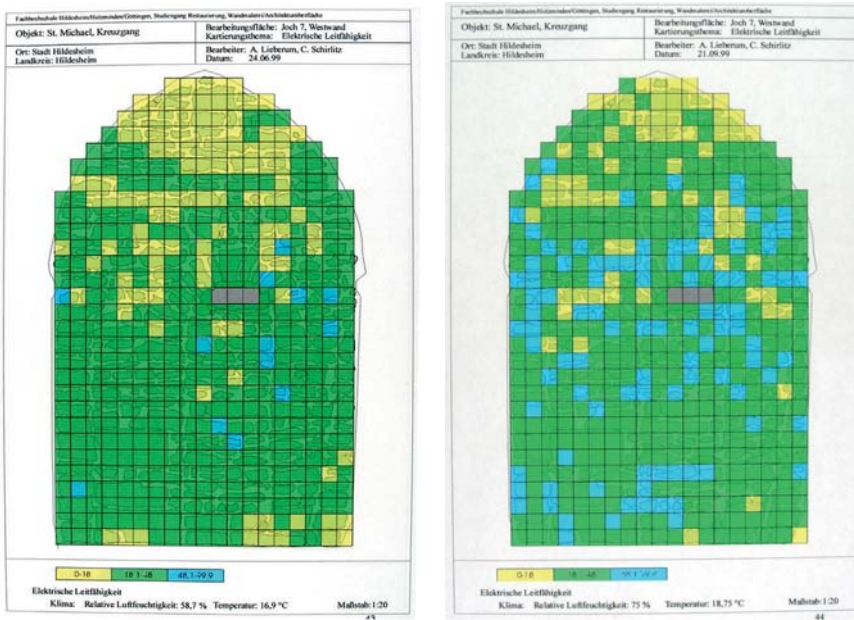
Fig. 22-23. Hildesheim, Germany, cloister of St. Michael, 11th-13th c., yoke 7, west wall; measurement of ELC; left: measurements on 24 June 1999, 58% RH, 17° C; right: measurements on 21 September 1999, 75% RH, 18 ° C T; both measurements shows that the infiltration occurs not only from the ground, but also from a source in the area of the vault, the one of the measurements has been performed below the Rheq of the salt mixtures (58% RH), the other is surely above it (75%). The comparison indicates to hygroscopic salts as significant source of moisture. By measuring the surface temperature thermal condensation could be excluded as a moisture source. HAWK / Lieberum, Schirlitz 1999.

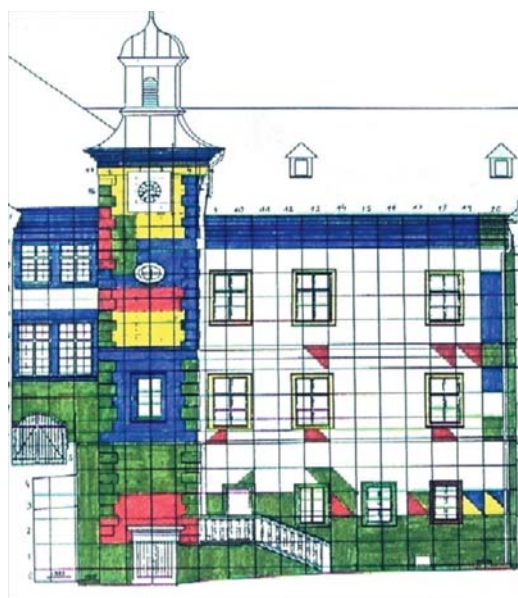
Fig. 25-26. Left: Forchtenstein, Burgenland, the castle courtyard, east facade, wall painting 1687; Quantitative recording of the conservation status by classifying the essential phenomena of decay. The strongest areas of weathering are identical with the lack of sunlight. Bundesdenkmalamt / Hammer, Fricke, Schleger, Skazel 1991; Right: Leiben / Lower Austria, castle, courtyard, documentation of the anticipated workload. Bundesdenkmalamt / Hammer, Tinzl 1996.

the mapping is vitally important. A small scale, *e.g.* a ratio of 1:100, is often more descriptive than a larger scale. Accuracy is not necessarily equivalent to the quantity of individual data, but corresponds to the careful selection of significant groups of phenomena. Sometimes, the choice of groups of phenomena can be nearly identical to the expected steps to be taken and the labour cost of conservation and repair (see fig. 26).
