Ivo Hammer, with contributions of Marko Goetz<sup>1</sup>

#### Prefabricated concrete coatings

#### Conservation and repair: who is doing what?

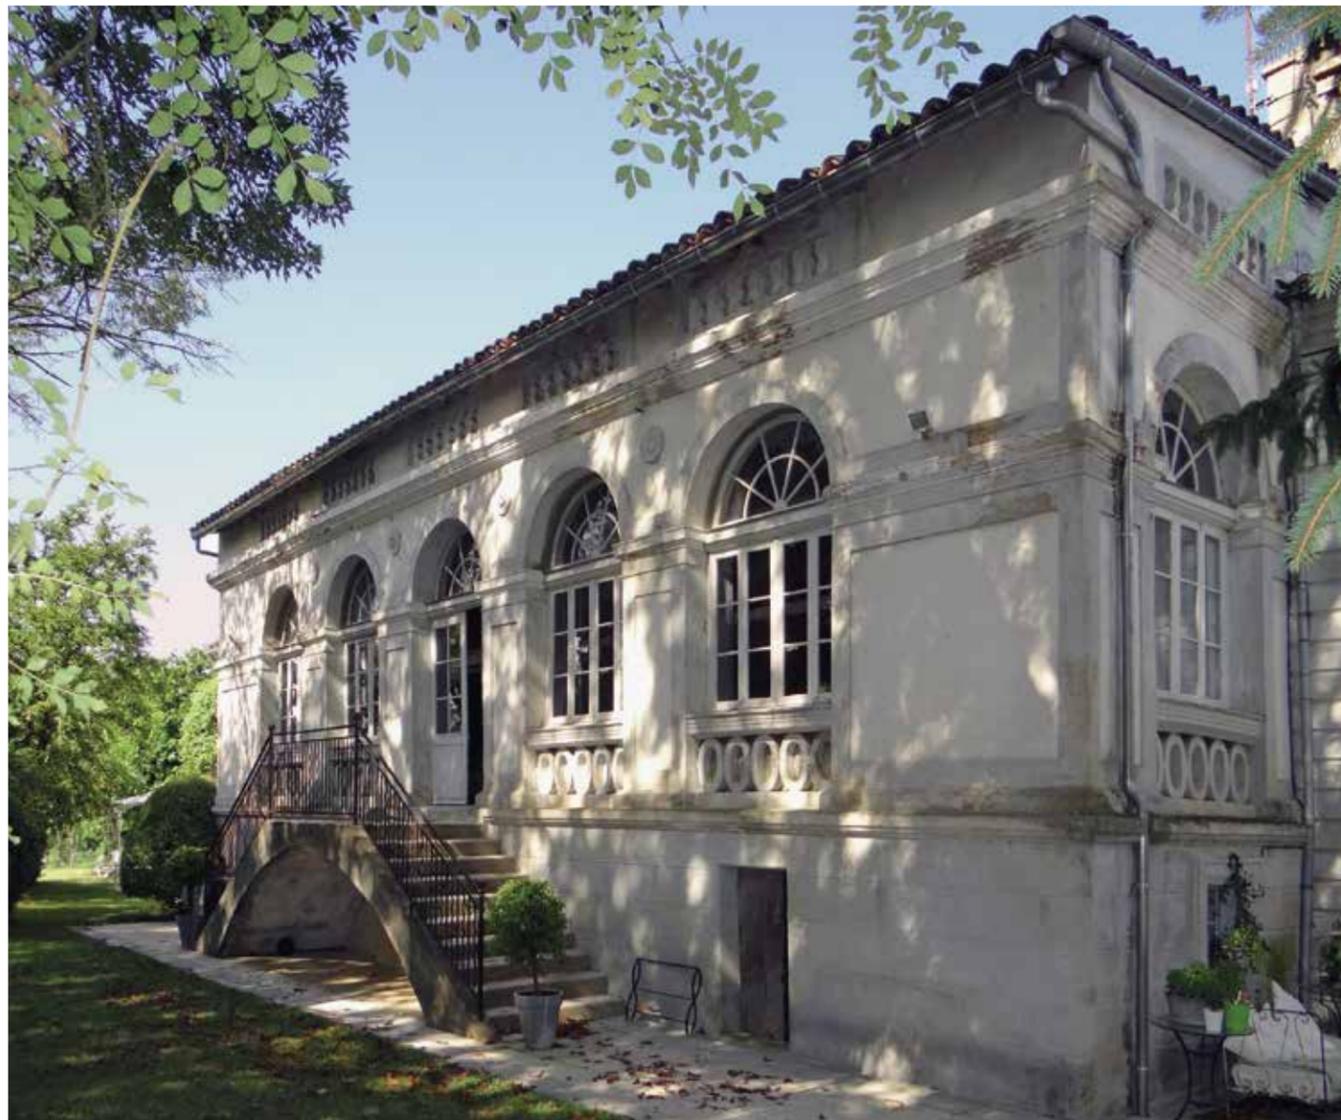
Villa Lebrun, 1828/29, Marssac-sur-Tarn; possibly the first known house since ancient times to be built entirely of concrete. The facade is whitewashed, most probably with lime, off-white and gray. Photo: Reinhard Dietrich, 2015, wikimedia commons.

stamped concrete with Portland cement, *béton aggloméré*,<sup>4</sup> based on the traditional *pisé* technique of rammed earth or rammed adobe and earlier buildings made of rammed concrete such as the Lebrun house in Marssac-sur-Tarn by Francois Martin Lebrun from 1828/29.<sup>5</sup>

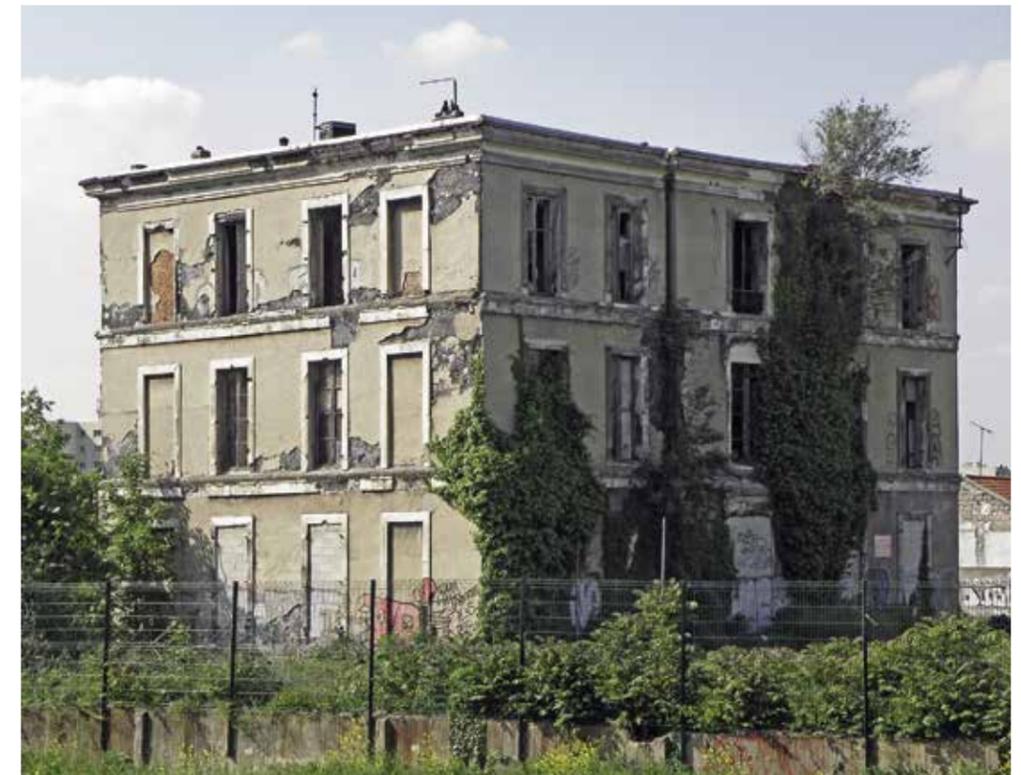
(right) Saint Denis, Maison François Coignet, 1853. "Monument Historique" since 1998. First house made of reinforced concrete, *fercement*. The facade is plastered. Photo: Eric Bajart, 2010, wikimedia commons.

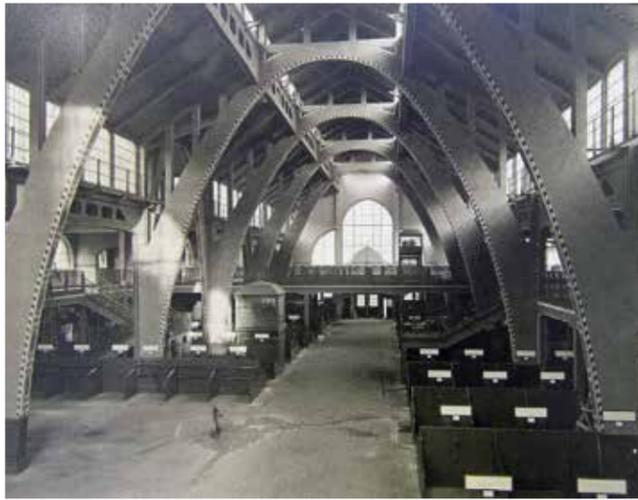
Breslau Market Hall (Hala Targowa) 1906-1908, Architects: Richard Plüddemann and Heinrich Küster. Reinforced concrete, the facade clad with exposed bricks, plaster and natural stones, "simple painterly treatment of the interior surfaces of the hall... whereby the concrete color of the supporting structures is retained and an element that is foreign to the building material is not brought into it by plaster and plastering work."<sup>10</sup> Photo: Ivo Hammer, 2009, after a historic photograph on site.

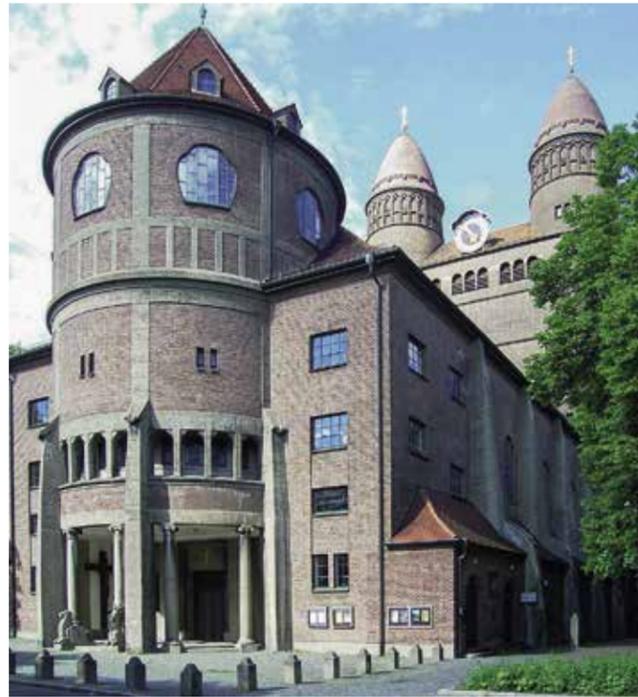
Ulm, ev. Paulus church, 1908-1910, according to plans by Theodor Fischer. Facade with pre-mixed concrete: trickled concrete (cement, sand, bean gravel 1:1:2), processed with two-pointed edge. Photo: Density, 2007, wikimedia commons.

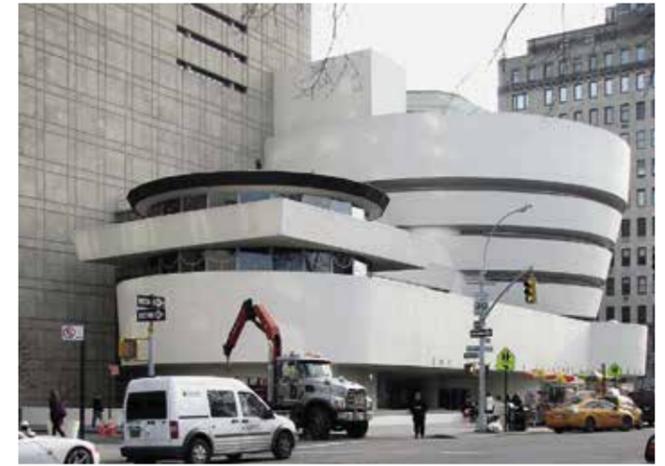
(right) New York, Solomon R. Guggenheim Museum, 1959, Frank Lloyd Wright. As-built imperfections and concealed repairs, most recently completed in 2008.<sup>26</sup> Photo: Ivo Hammer 2012.

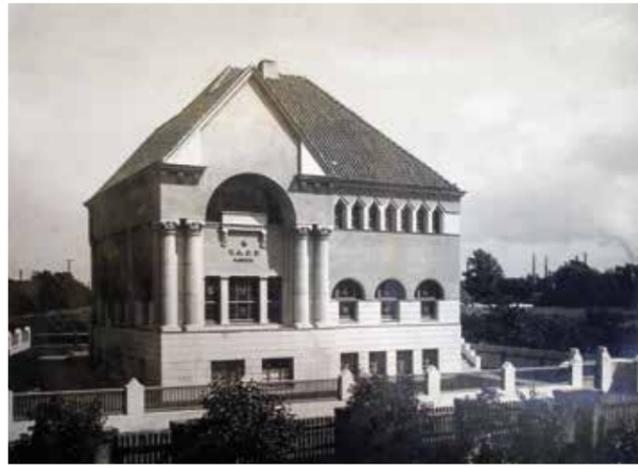
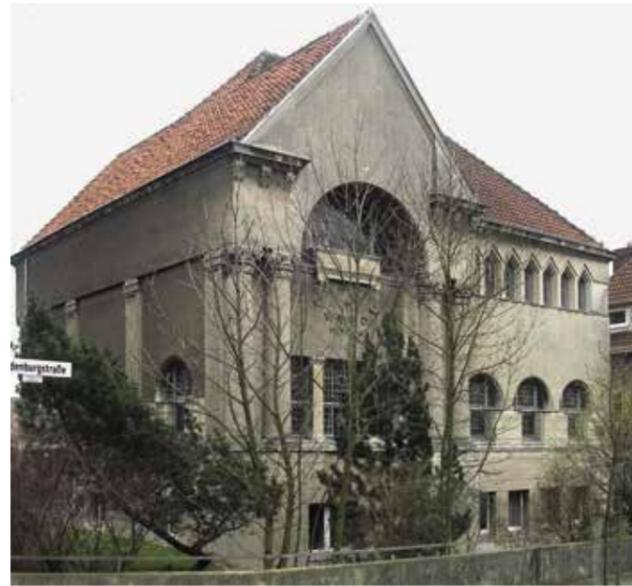
Peine, Lessing Lodge, east facade. Representative design of the facade by changing the surface arrangement; (blue): scratched plaster; (yellow): cast concrete plaster, dressed by a stone mason using a charring chisel; (green): dressed concrete, partly prefabricated before transferring it to site. Photo / graphic: HAWK / Götz, 2007.

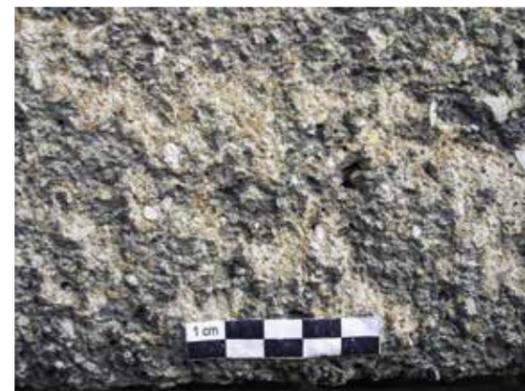
Peine, Lessing Lodge, west facade, detailed view; the scratched plaster surface, before conservation. Photo: HAWK / Götz, 2007.

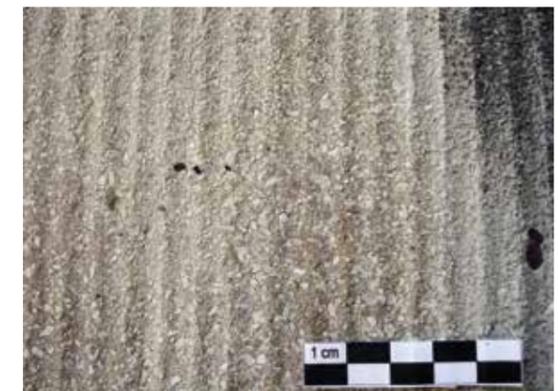
Peine, Lessing Lodge, east facade, base, detailed view: cast concrete plaster with horizontal joints and dressed treatment by chisel. Photo: HAWK / Götz 2007.

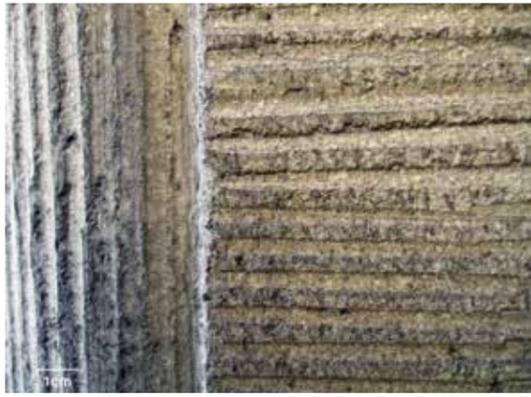
Peine, Lessing Lodge, east facade: alternating dressing on the concrete stone of the window frame with a well preserved surface.  
Photo: HAWK / Götz, 2007.

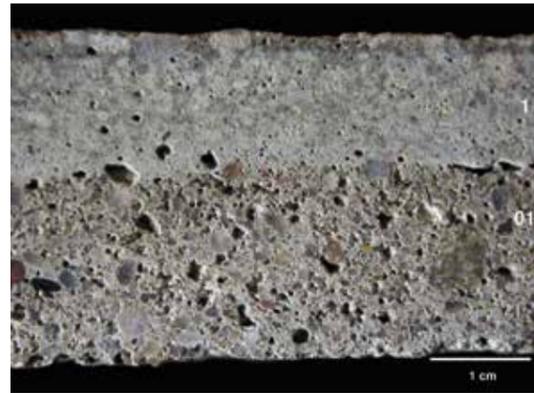
Peine, Lessing Lodge, cast stone plaster: sample / transversal layer in angled light / daylight with flush-mounted and adhering plaster.  
Photo: HAWK / Götz, 2007.

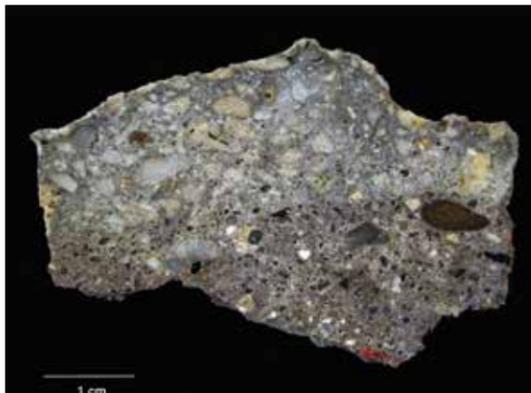
Cast stone: sample / transversal view under angled light / daylight with core (1) and facing concrete (2).  
Photo: HAWK / Götz, 2007.

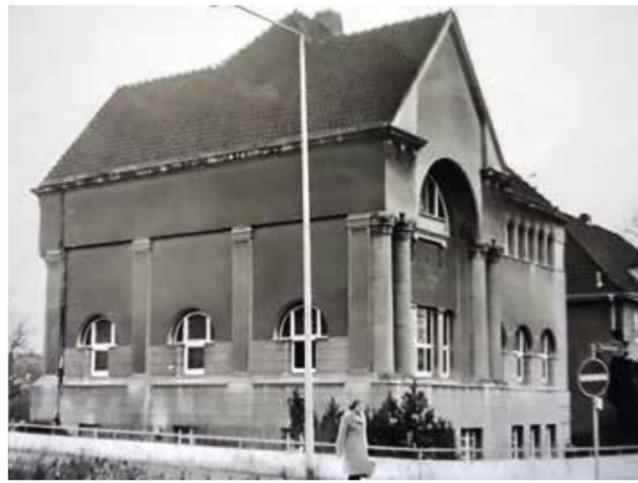
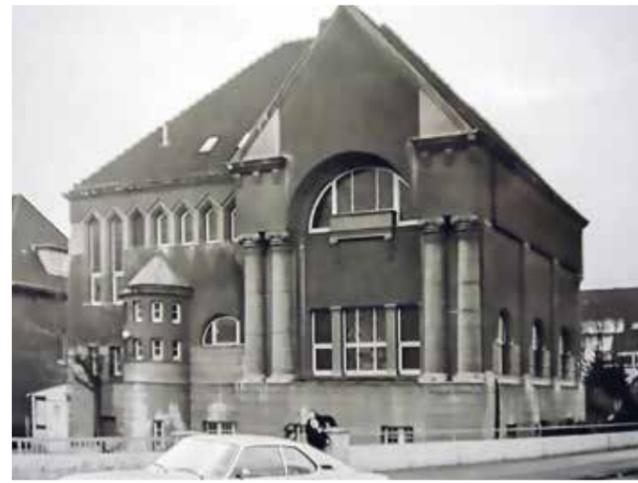
Peine, Lessing Lodge: The two pictures from 1973 show the north and west (left) and east façade (right). The surfaces are very dirty. Signs of weathering can be clearly seen on the scratch plaster and plinth surfaces.  
Photo: Unrein, 1991.

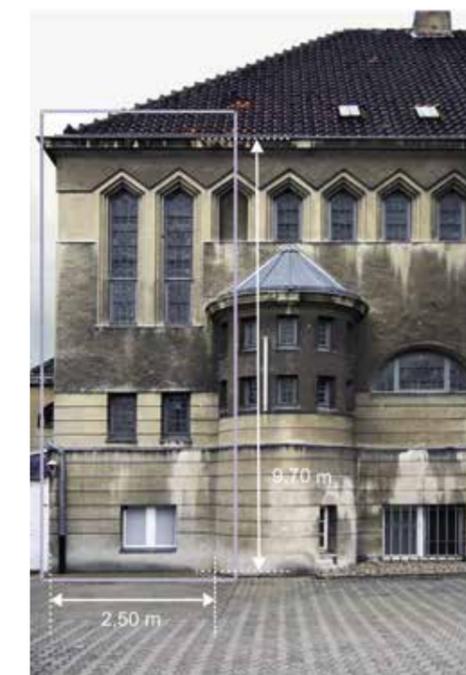
Peine, Lessing Lodge, east facade, position, dimensions and condition of the pilot area before conservation.  
Photo: HAWK / Götz, 2007.

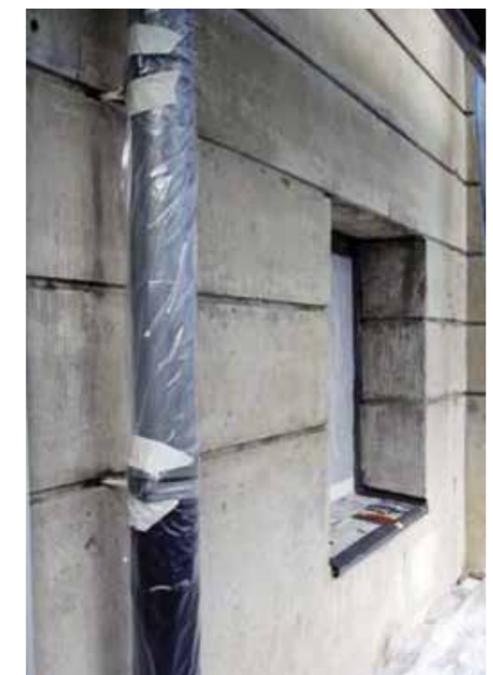
Peine, Lessing Lodge, east facade, base: cleaned surface.  
Photo: HAWK / Götz, 2007.

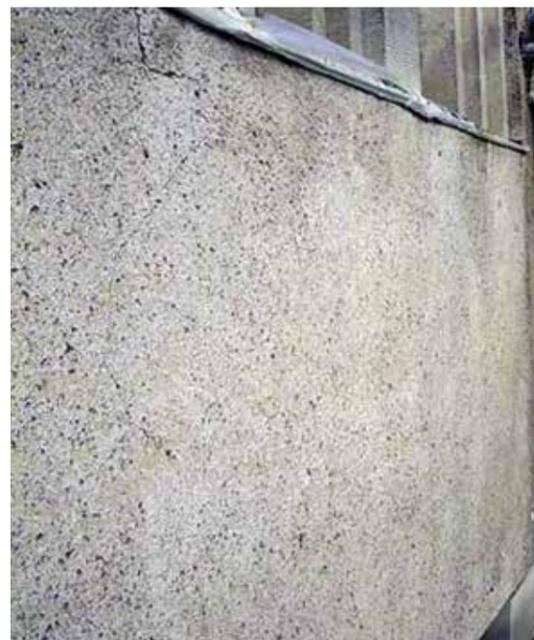
Peine, Lessing Lodge, east facade, scratched plaster: cleaned surface. Photo: HAWK / Götz, 2007.

By means of cleaning and conversion of gypsum the physical properties of the surface should be restored as far as possible, and thus further loss of the original plaster surface should be prevented. At the same time, the aesthetic appearance of the facade should be improved and the disturbing damage phenomena eliminated. Various methods of cleaning were tested in advance: steam cleaning, applied poultices (with and without the addition of surfactants<sup>31</sup>), cleaning with a microfine jet device<sup>32</sup>, cleaning with pure ammonium carbonate and with deer horn salt, *Hirschhornsalz*.<sup>33</sup>

Tylose® was apparently dry and mechanical foaming of the Tylose® with the help of brushes became inevitable. It turned out that at least three repeated attempts (foaming and rinsing) were necessary in order to be able to remove the paste without residue. The cellulose residues could be checked optically by examining the surface for sparkles in the raking light. It should be noted that the cleaning process could be carried out much more effectively and with less manual effort by using suitable machines with appropriate brushes. In view of isolated dirt pockets in the recesses of the scratched plaster surfaces, a second cleaning cycle was carried out to completely remove the dirt.

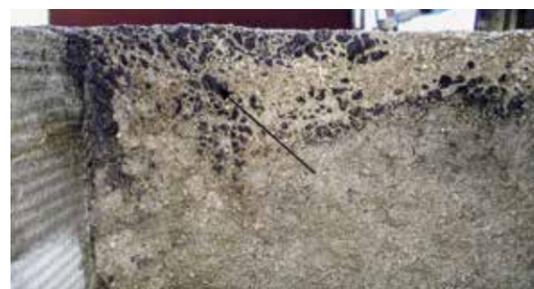
Peine, Lessing Lodge, east facade, basement, detail, surface of the lintel. Crusting and blackening in the edge areas despite cleaning twice. Photo: HAWK / Götz, 2007.

and incrustations could not be removed even in a second cleaning cycle. In order to be able to clean these areas, the cleaning paste was modified. A 20% pure ammonium carbonate solution replaced deer horn salt, mixed with 4% Tylose® and 50 g beech cellulose Arbocel BC 200®.<sup>36</sup>

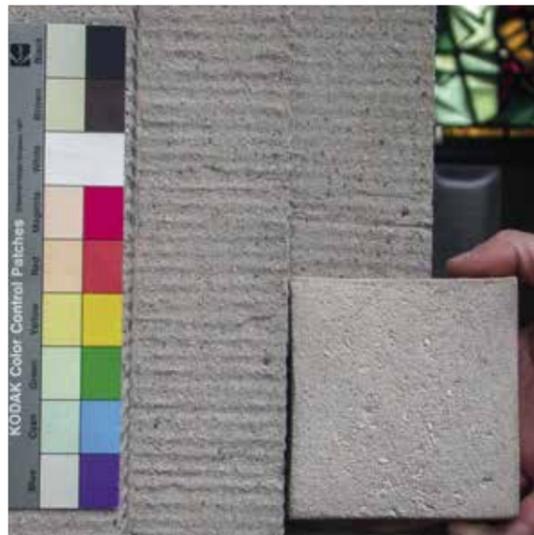
Repair mortar we assembled in comparison with the construction concrete block at the stucco border of the entrance area.  
Photo: HAWK / Götz, 2007.

The starting point for the development of a repair mortar was the knowledge that we gained through our conservation-science study. We assembled a repair mortar that corresponded to the original concrete in terms of materials and techniques, surfaces, color and grain size of the binders and aggregates, and that protects the reinforcing steel through alkaline passivation. The selection of the binding agent and the aggregate was based on the original materials in the damaged areas. The repair mortar could be adapted to local conditions using colored sands.

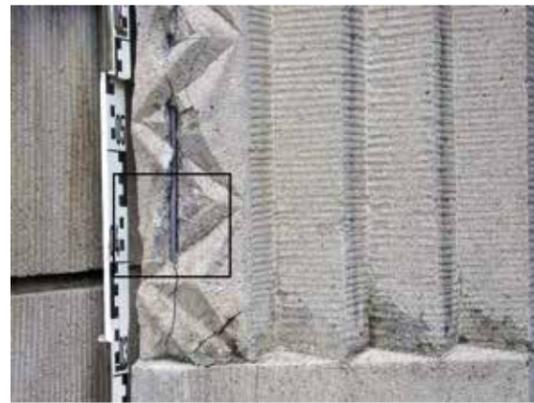
Peine, Lessing Lodge, west facade, entrance area / stucco edging. Damage in the cast stone. The corrosion products on the iron reinforcement were removed with the sandblaster.  
Photo: HAWK / Götz, 2007

The corrosion products (rust) were removed by sandblasting with the blasting material Edelkorund®, 110 mm (Al Six). The edge areas of the flanking plaster mortar were also worked on to ensure that no corrosion products adhered to the iron or plaster. The area was then thoroughly cleaned with compressed air to remove dust and sandblasting particles.

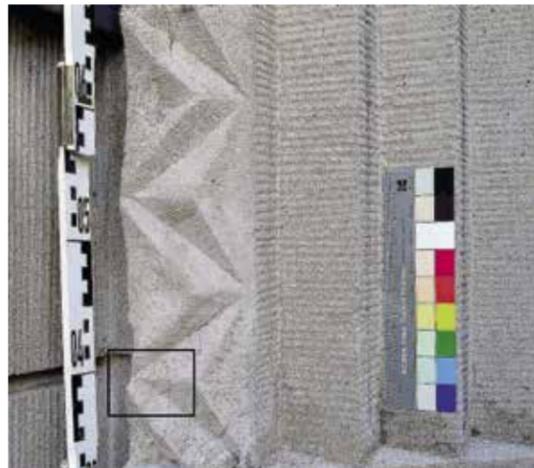
Peine, Lessing Lodge, west facade, entrance area / stucco edging. Condition after the repair. The repair plaster adapted very well in color and structure to the original material.  
Photo: HAWK / Götz, 2007.

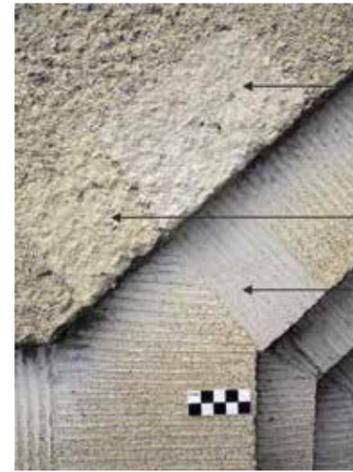
Peine, Lessing Lodge, east facade, pilot area, whitewash A, B and C. Photo: HAWK / Götzt, 2007.

The linseed oil, which is temporarily stored in fine molecules, is saponified relatively quickly by the strongly basic calcium hydroxide. For this reason the linseed oil only has a temporary blocking effect. The whitewash was brushed once onto the thoroughly pre-wetted surface like a wafer-thin membrane. The structure and the materiality of the whitewash came very close to the structure of the original surface. The weathered parts of the surface could be adapted well to the less weathered parts. The architectural structure was once again perceptible as an esthetic unity and the visual impression of the color was again determined by the different structure of the concrete stone plaster and the scratched concrete plaster surface.

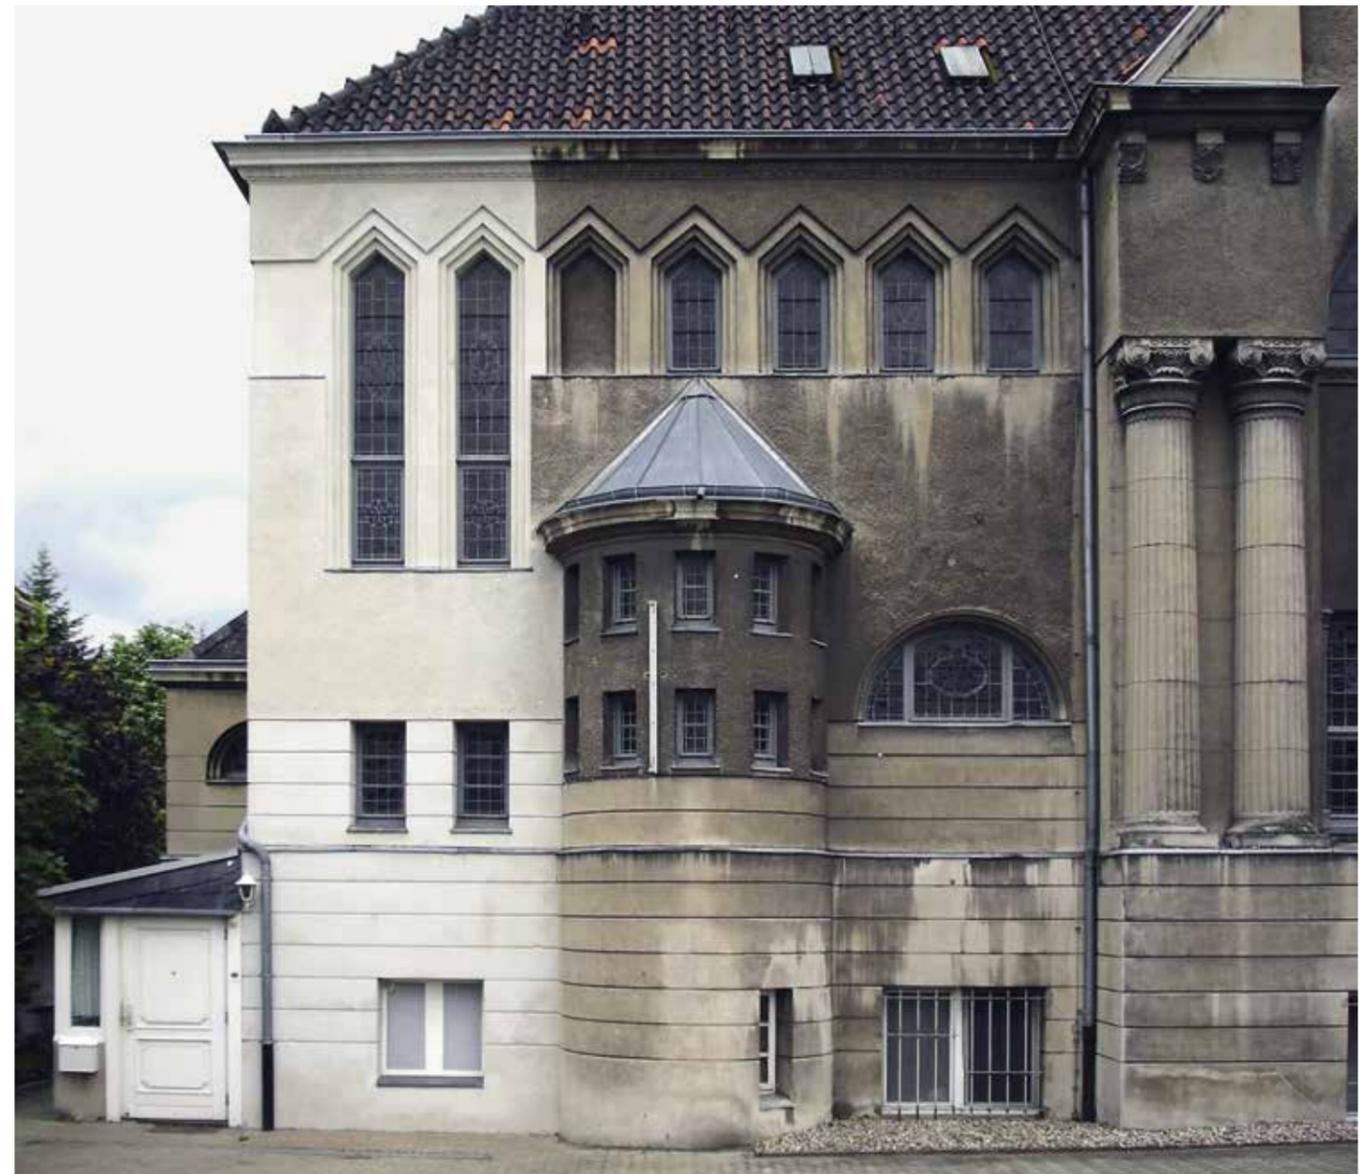
Peine, Lessing Lodge, east facade, condition after the intervention layer was applied. Photo: HAWK / Götzt, 2007.
