Ivo Hammer

Some further impression Brnec "Schindlers Ark" (visit in September 20, 2021)

(with additions to my report of June 23, 2021)

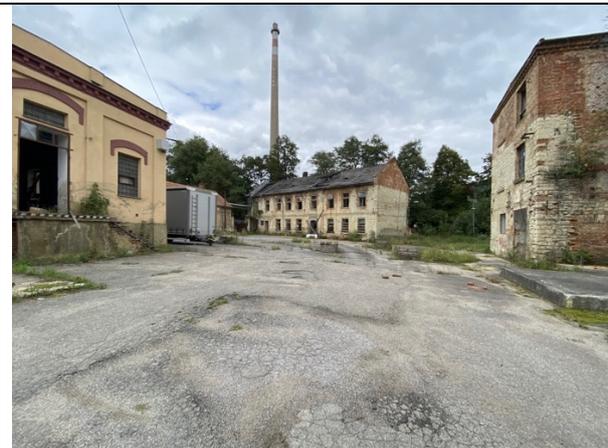
Brnec, looking north (from left): former plumbing workshop (ca. 1895?), SS-building (mid 19th c.), Schindler's Ark. Foto: Ivo Hammer 20.09.2021

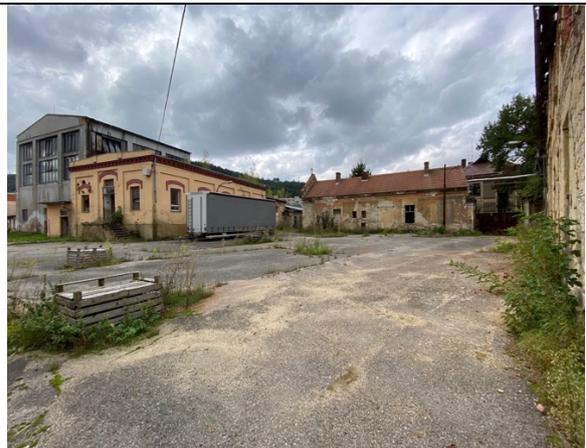
Brnec, looking west (from left): heating plant, plumbing workshop, administration building, south wall of SS-building. Foto: Ivo Hammer 20.09.2021

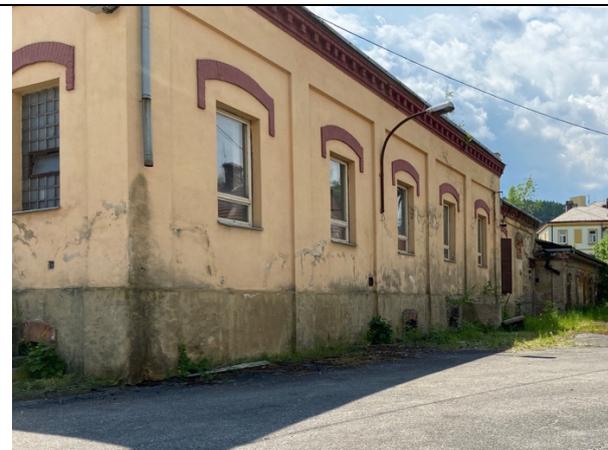
Brnec, looking south-west: plumbing workshop. Foto: Ivo Hammer 9.6.2021

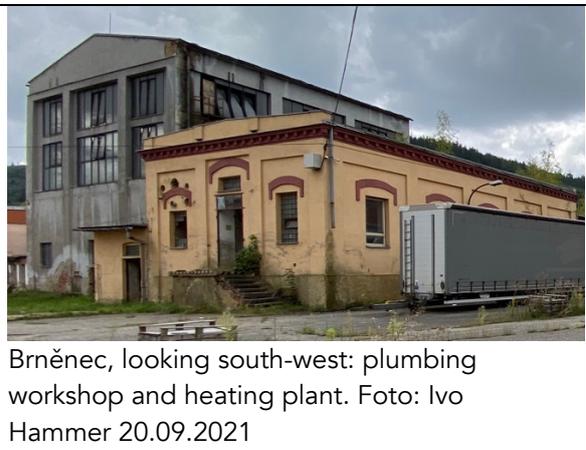
Brnec, looking south-west: plumbing workshop and heating plant. Foto: Ivo Hammer 20.09.2021

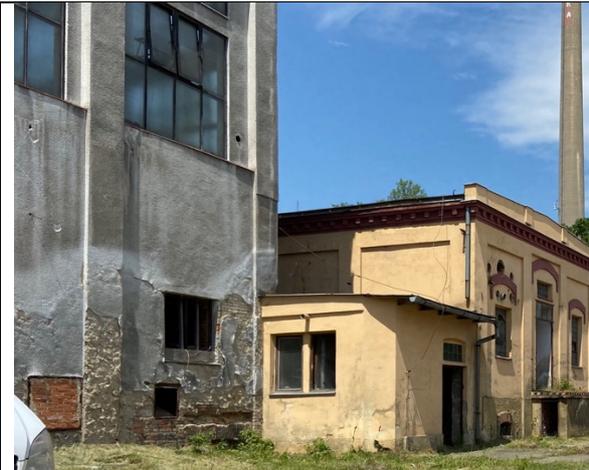
Brněnec, looking north-west: heating plant/boiler room building, social facility and plumbing workshop. Foto: Ivo Hammer 20.09.2021

There is also a connecting wing between the two buildings: The former **social facility**. It is based on stone and concrete foundation strips. Floor plan dimensions of the building 5.30 x 16.60 m. It is a single-storey building, located and integrated between PW and BRB as a background for the workshop and boiler room. There is a dressing room, shower and toilet, hallway and storage. Brick masonry, roof made of wooden saddle trusses with one skylight, bituminous roofing, concrete floors. Wooden windows, wooden doors. Partly in a destroyed state, without any equipment, without electricity and BTI.

I can accept that the former social facilities, situated between PW and HP building is being demolished and modern facilities are being built at this point.

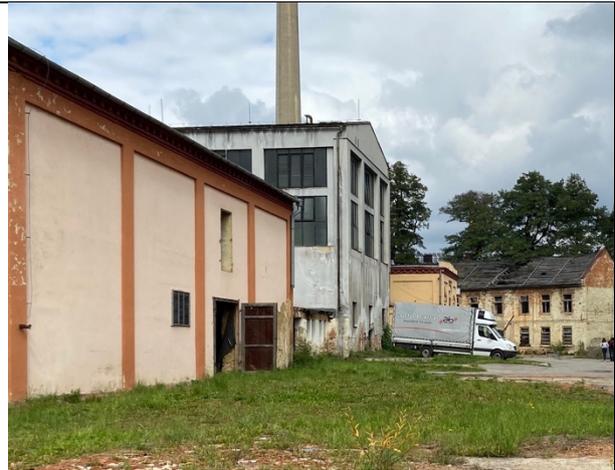
Brněnec, looking north-west (from left): extension of big spinning and carding hall, heating plant, social facility (covered by truck), plumbing workshop and SS-buildng. Foto: Ivo Hammer 9.6.2021

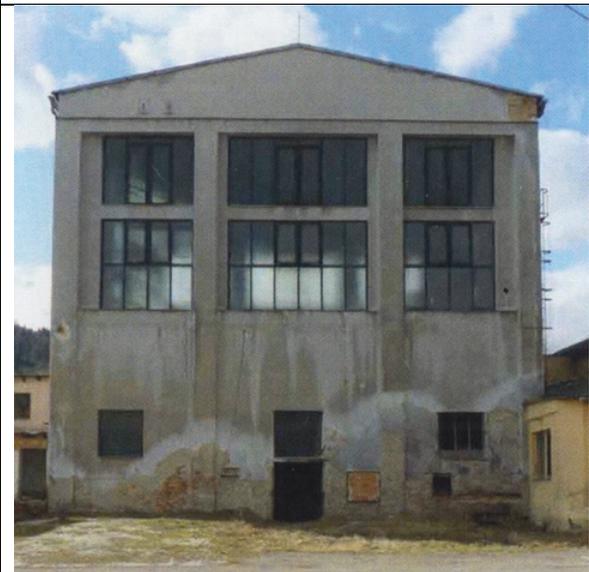
Heating plant/boiler room building. Foto: Helena Zemanková, Conversion of the Factory in Brnenec to Polyfunctional Area, Brno 2020

The second building is the former **heating plant/boiler room building (HP)**. This building probably dates from 1961. The boiler room building has floor plan dimensions of 15 x 14.6 m. It is based on concrete footings. It is a three-storey building, with a partial basement. The building is reinforced concrete with brick filling. It is covered by a saddle roof, which is formed by steel trusses, the roofing is sheet metal - profiled sheet metal. Reinforced concrete ceilings, steel windows with glass filling, construction without the former technology - steel boilers and heating distribution, electrical distribution and BTI. Everything has been dismantled in 2012. The façade is plastered with scratched greyish plaster (perhaps *Břizolit*). A thin lime wash could give to the building a more friendly appearance. The pillars consisting of reinforced steel could be painted in a color different to the plastered surface of the façade.

The heating plant (from 1961?) Is a clearly structured industrial building with the sobriety inherent in an industrial building, but at the same time also clear in proportions, with two upper floors flooded with light.

The current damage caused by moisture in the foundation area, which probably happened when the heating was stopped, can be repaired with not too big effort.

As indicated in one of the student works, this building could also be used as a building for facilities and exhibitions and workshops, lecture rooms.

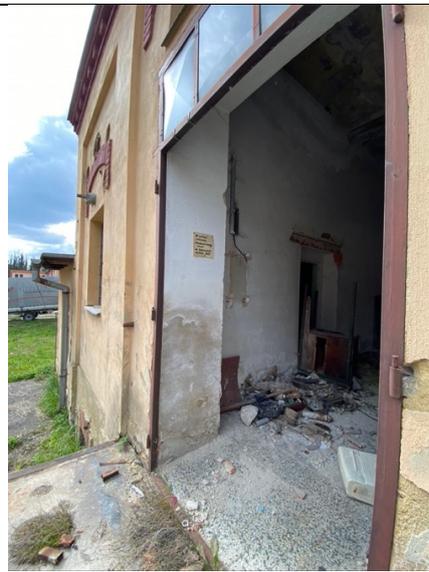
Brnenec, plumbing workshop, west façade, entrance, looking south.

The building of the former **plumber's workshop (PW)**, which in my report dating from June 23, 2021 I wrongly called carding building after the somewhat confusing description on the plan from 1982. The building should date from around 1895, so it was in any case the fourth side of the courtyard in which Schindler's Jews stood in front of the SS guards. It is based on stone and concrete foundation strips. Floor plan dimensions of the building 19.20 x 10.0 m. A two-storey building, the subterranean basement with windows, the roof covered with a saddle truss made of wood. Bituminous roofing, brick masonry, reinforced concrete ceiling. There is a space of a former workshop, with three divided wiring. In the basement there used to be a heating distribution. All the furnishings in the building have been demolished, but the fabric of the building is largely intact. The façade is covered with a smoothed plaster and painted with a pale yellowish color, the brick decorations in dark red. A very opaque paint, perhaps a resin-paint, not very pleasant. The pilaster strips of the interior walls are connected with flat arcades. The ceilings consist of reinforced concrete cast on site between steel bars. The interior walls are apparently painted with lime.

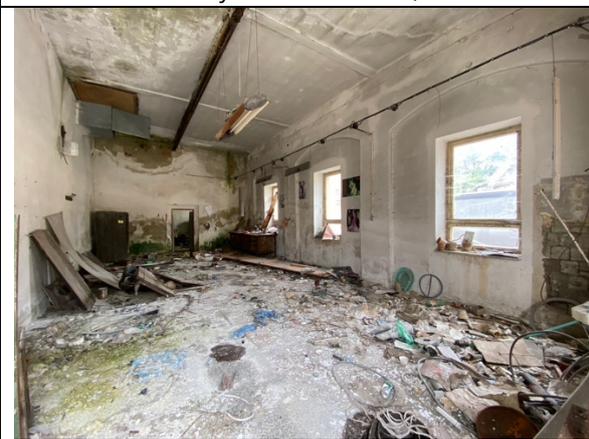
Brnenec, plumbing workshop, interior, looking west. Foto: Ivo Hammer 20.09.2021

Of course, there is some damage caused by moisture infiltration.

But this building could easily be converted and furnished as a restaurant, or as an exhibition room or lecture room, with a view of the courtyard of the concentration camp and the three other buildings.

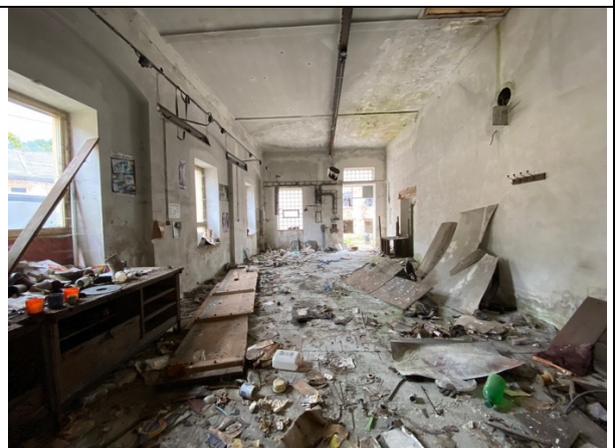
Brnenec, plumbing workshop, interior, looking east. Foto: Ivo Hammer 20.09.2021

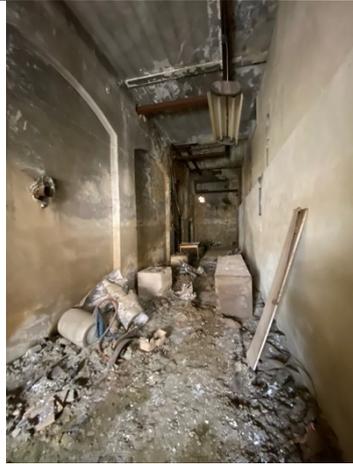
Brnec, plumbing workshop, interior, couloir, looking west. Foto: Ivo Hammer 20.09.2021

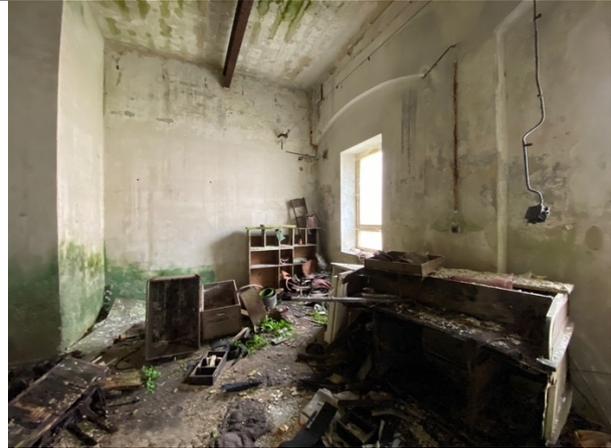
Brnec, plumbing workshop, west façade, entrance, looking south. Foto: Ivo Hammer 20.09.2021

The **HP (Heating Plant)** and the **PW (Plumbers Workshop)** are, I repeat, both in good condition in terms of the building fabric.

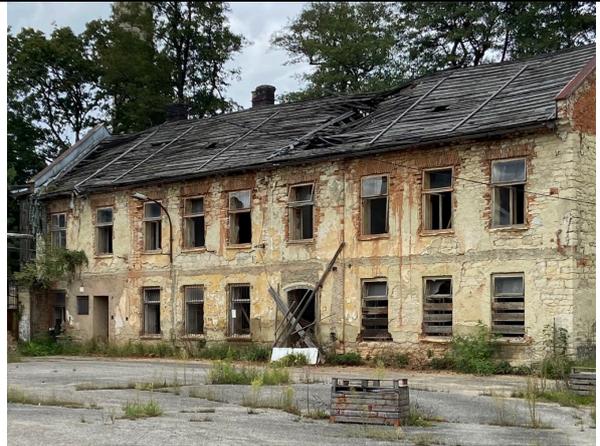
Regarding the emergency security, they only stated that this obligation was the owner's. They could not provide any concrete suggestions. The architect, too, only shrugged his shoulders when asked how he would proceed with the emergency security of the SS building.

Brněnec, SS-Building. Photo: Ivo H20.9.2021. Dramatic acceleration of the damage of the roof.

I am not an architect. But I could imagine that you could put a tear-resistant tarpaulin on the roof with a steel cable that is stretched from gable ridge to gable ridge. This tarpaulin could be stretched onto the roof with additional ropes. But these are of course costs for which there is apparently no cover and which - in contrast to the new building - have not been applied for.

In the meantime, in December 2021, Daniel Low-Beer took the initiative at his own expense. He commissioned the professional provisional covering of the destroyed roof of the SS building.

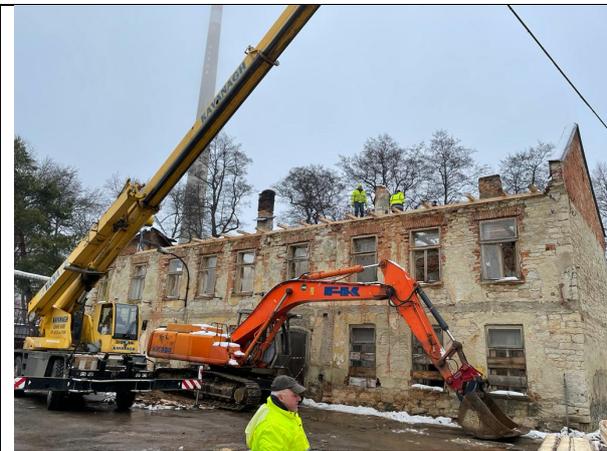
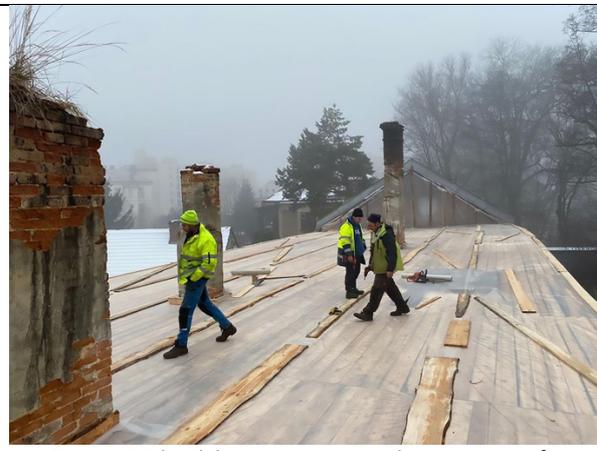
Brněnec, SS building, provisional covering of the destroyed roof; photo Daniel Low-Beer, December 2021
