Journal 44 – 2011/1

Modern and Sustainable

The Tugendhat House: Between Artisan Tradition and Technological Innovation. Preservation as Sustainable Building Policy¹

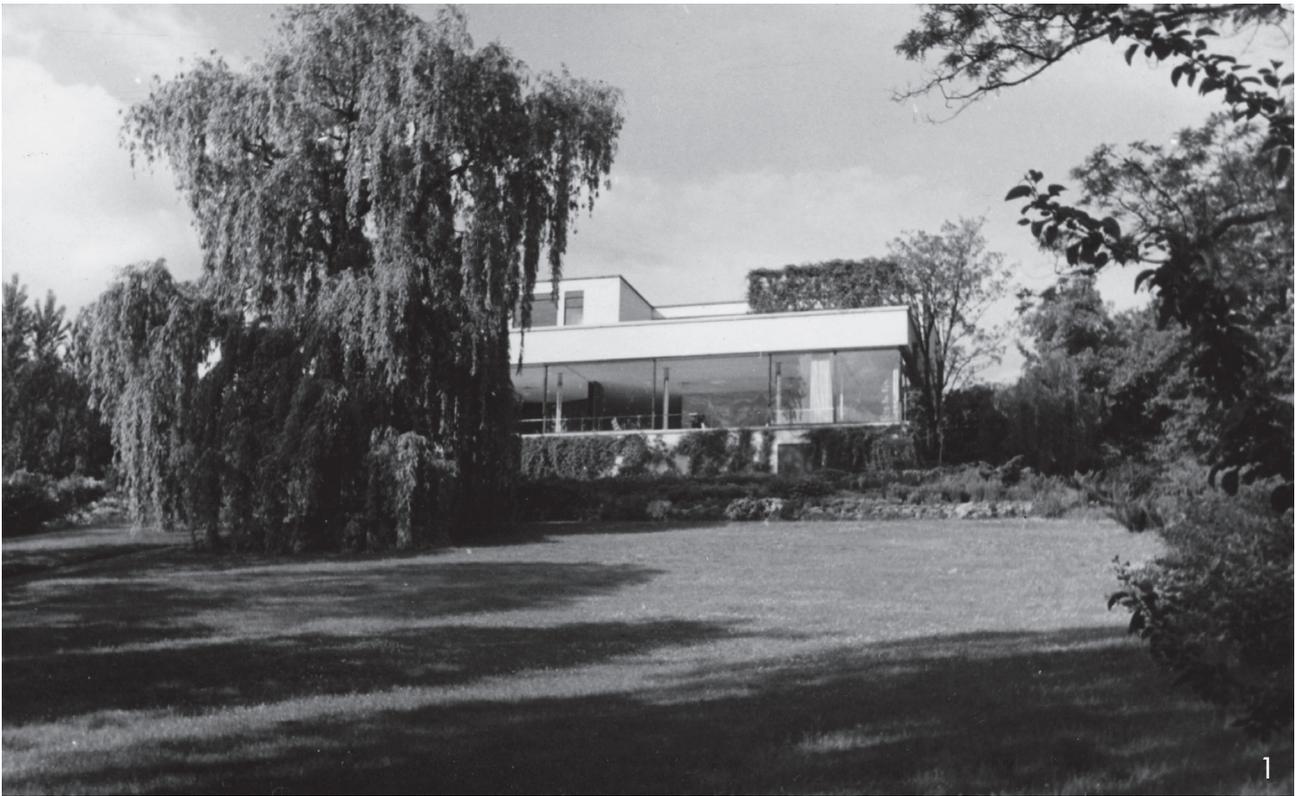
1

Figure 1. Tugendhat House, Brno, 1928–30 by **Ludwig Mies van der Rohe** and **Lilly Reich**. View from the south with the garden. The lower portion of the house is covered with vegetation. Photo by Fritz Tugendhat, circa 1935. (Repro: Dieter Reifahrt 2008).

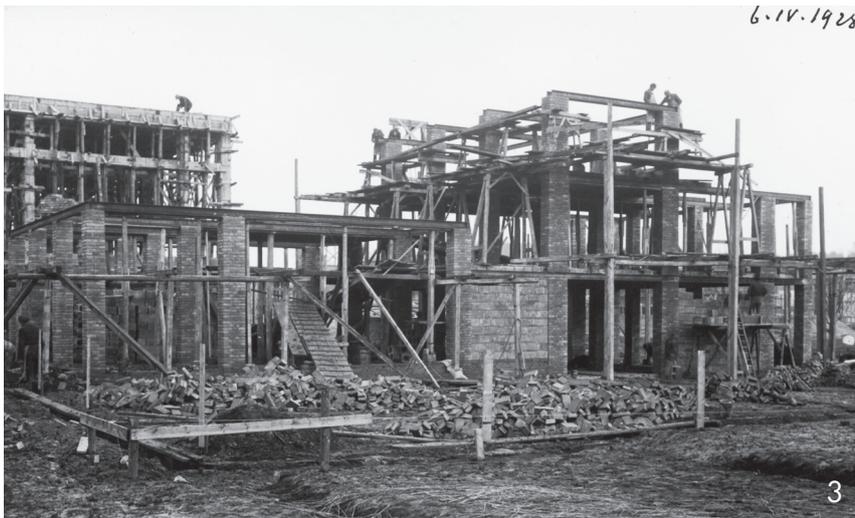
Figure 3. Fairgrounds, Pavilion of Arts and Crafts School in Prague by **Pavel Janák** during construction (1927–28). Brick-clad concrete base, hollow block brick wall, wood chip board, steel girders. Photo by the National Technical Museum in Prague.

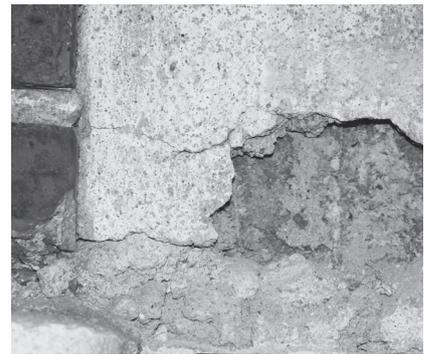
Figure 4. Fairgrounds, Pavilion of Arts and Crafts School in Prague by **Pavel Janák** (1927–28). South wall, detail, fragment of the original façade plaster, which was smoothed out with a wooden board, and covered with yellowish lime wash. Photo by HAWK Hildesheim 2005.

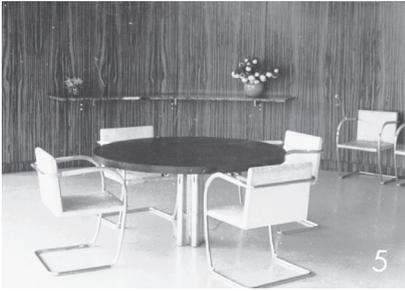
5

Figure 5. Tugendhat House, Brno, 1928-30, showing the semi-circular dining area with walls covered with a veneer of Makassar ebony and the storage shelf of greenish Verde Tinos marble. The cross-shaped steel leg of the round table, with chrome-plated and polished cladding of brass, is fixed in the concrete screed, the Xylolith floor is covered with whitish linoleum, the buffet also veneered with Makassar ebony. The Brno chairs in chrome plated tube steel, are upholstered with whitish vellum upholstery. Photo by Fritz Tugendhat, 1931.

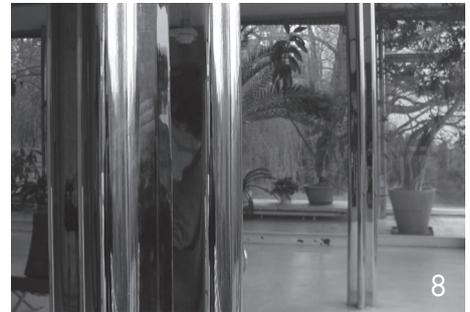
8

Figure 8. Tugendhat House. Main living space, showing the detail of the polished chrome cladding of the cross-shaped steel columns. In the mirror, the subtle unevenness of the surface of the metal caused by the craft fabrication process is clearly visible. Photo by Dieter Reifahrt, 2008.

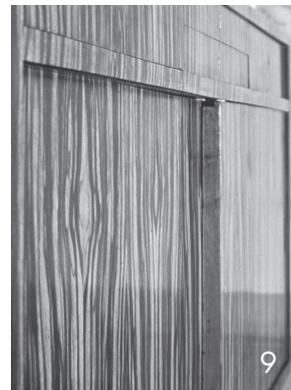
9

Figure 9. Detail of the dining room buffet from the Tugendhat House, now in private ownership in Vienna. The shadow of a straight line in the reflection of the surface shows a slight ripple caused by the properties of the material and also by the manufacturing process. Photo by Ivo Hammer, 2010.

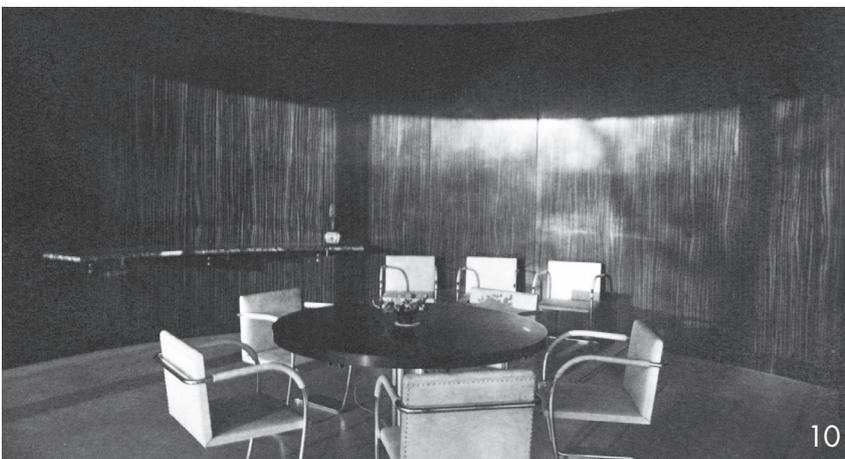
10

Figure 10. Tugendhat House. Main living space with the, semi circular Makassar ebony wall reflecting the light of the big glass walls and giving an image of nature on the outside. The slight irregularities of the surface of the veneer are perceptible. Photo by Fritz Tugendhat, ca. 1931, detail.

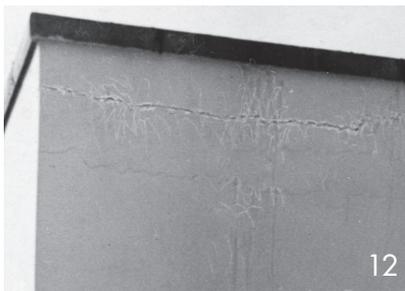
Figure 12. Tugendhat House. Detail of the east façade of the bedroom of Grete Tugendhat. Shortly after the building was completed, cracking of the plaster took place at the intersection of the concrete ceiling and the brick wall caused by different thermal movements of the materials, a built-in drawback created by the combining innovative and traditional techniques. Photo by de Sandalo, detail, with original retouche, ca. 1931.

The steel skeleton—a technological innovation for a detached residential house—and the concrete floors in conjunction with the traditional infill of bricks (and the Torfoleum insulation)—coated with highly hydraulic lime-cement plaster have its drawback due to the different coefficients of thermal expansion and contraction of the materials used. The crack between the ceiling structure and the façade did—according to the evidence of the photos from 1931—appear soon after completion and was repaired—in vain—immediately afterwards with lime paint using the original technique [figure 12].¹⁸

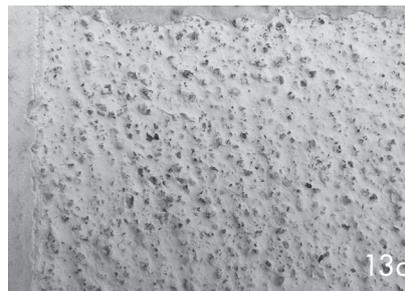
Figure 13. Tugendhat House. Upper terrace, façade, detail. 13a. The image width corresponds to about 10 cm. 13b. The image width corresponds to about 17 mm. The yellowish-white lime wash on the grated wall is so thin that the color of the sand grains play a role in the overall color of the mortar. Photos by HAWK, Hammer (a) and Hitzler (b).

The wall and ceiling surfaces are executed with a quite exceptional precision taking advantage of traditional techniques. The ceiling on the interior is suspended, which was common since the introduction of concrete ceilings at the end of the 19th century. A traditional support of the plaster consisting of (prefabricated) mats of reeds and of Rabitz netting is suspended from the concrete floor with rebars at a distance of about 40 cm. The plaster itself is comprised of lime and some gypsum. Due to the suspension and the flexible reeds there is both an excellent thermal insulation and a mechanical elasticity and thus durability. To date, the ceilings are largely in good condition and do not show cracks. Even for the surfaces of the walls and ceiling of the interior, the architects resorted to a technique called *stucco lustro*, used since ancient times in substantial buildings as in villas by Andrea Palladio, and again in the 19th century, as, for example, in the architecture of Friedrich Schinkel.²² The *stucco lustro* of the Tugendhat House had a rather mat than glossy finish, similar to the famous 'Marmorino' e.g. of the *Teatro Olimpico* of Andrea Palladio. In the period in which the Tugendhat family lived there, from 1930-38, the walls were not covered with paint, but cleaned only by rubber gum (bread) [figure 13, 15].

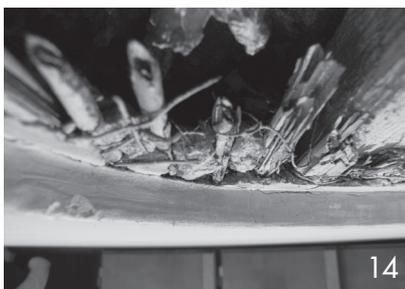
Fig. 14. Tugendhat House. Fritz Tugendhat bedroom. Opening in the ceiling, where light fixture has been removed. The prefabricated cane mat is suspended from the concrete floor structure above and supported by a wire mesh.

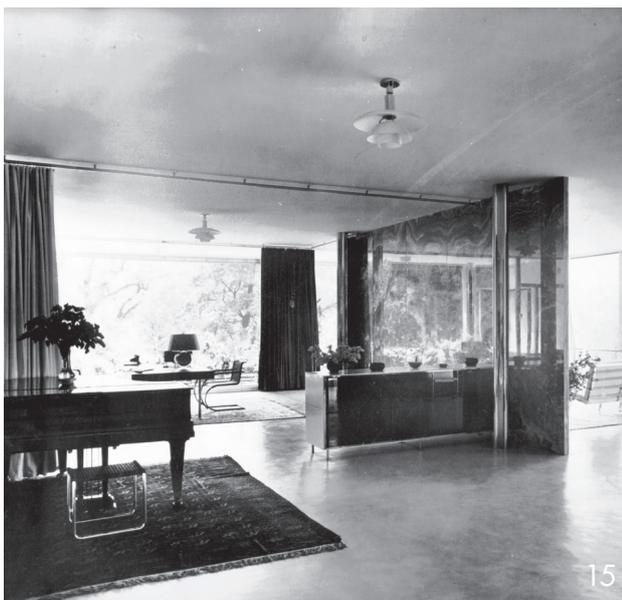
Figure 15. Tugendhat House. The main living room, looking southeast. The reflections of the wall surface convey an impression of the Stucco Lustrato surface. Photo by de Sandalo, 1931st.
